UNITED STATES ENVIRONMENTAL PROTECTION AGENCY

Re: **Request for Information**
Docket No. CWA-IR-16-033
EPA Audit Report – July 7-9, 2015
Town of Southampton Municipal Separate Storm Sewer System
SPDES No. NYR20A454

Water Compliance Inspection Report

Southampton MS4 Audit Photograph Log

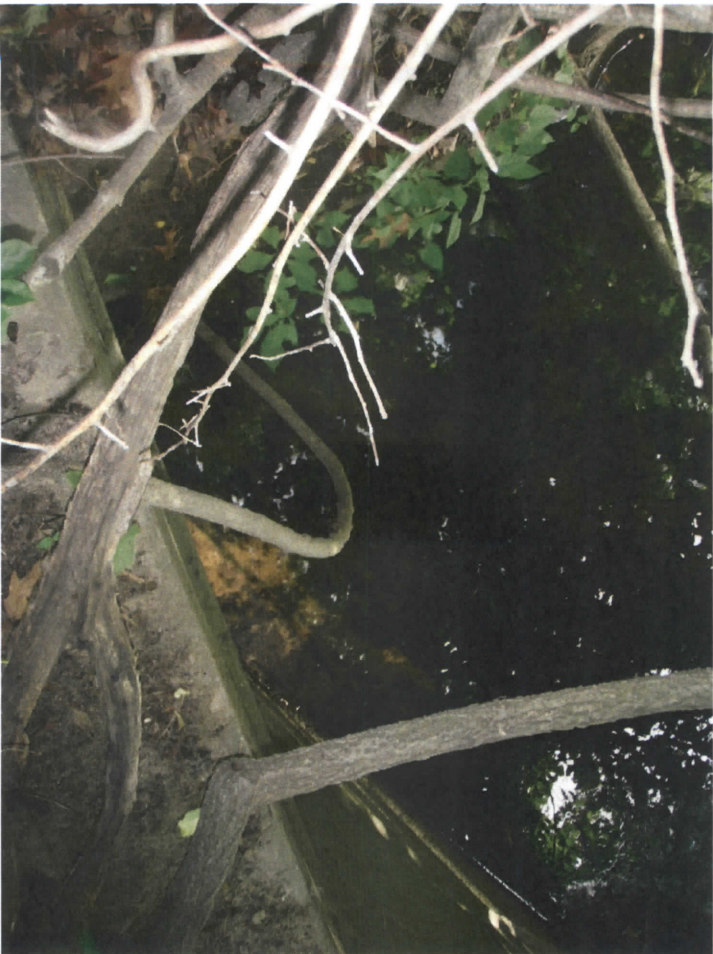
P7090092: Outfall 38, flowing (top right of photograph). This pipe conveys Silverbrook Pond to the north side of SR-24, however there appears to be a blind MS4 connection from Oak Drive. Outfall was hard to access due to woody vegetation.

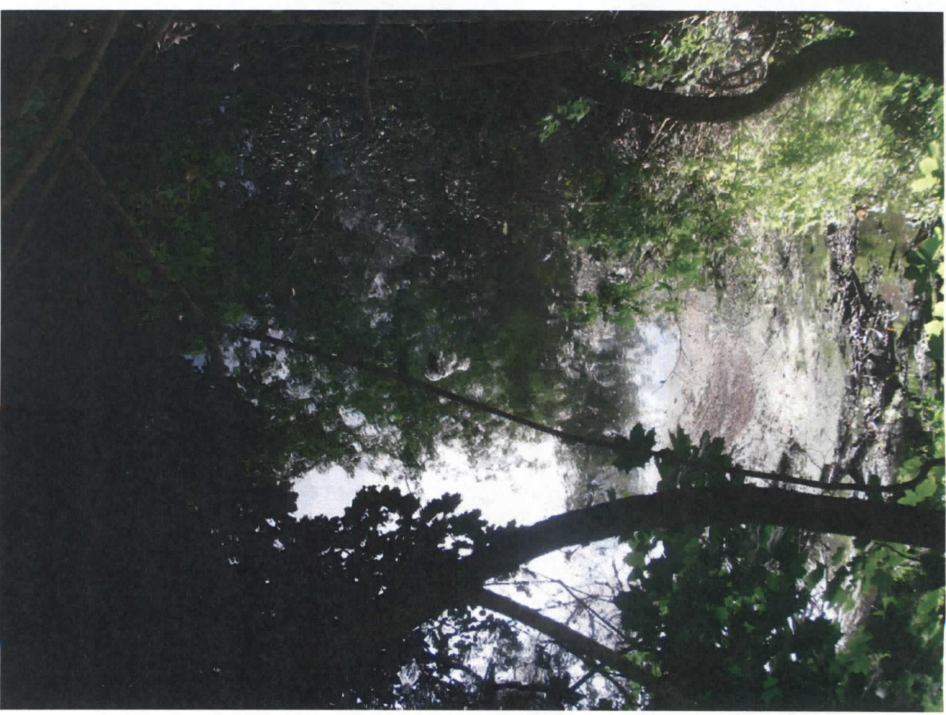
P7090093: Area downstream of Outfall 38

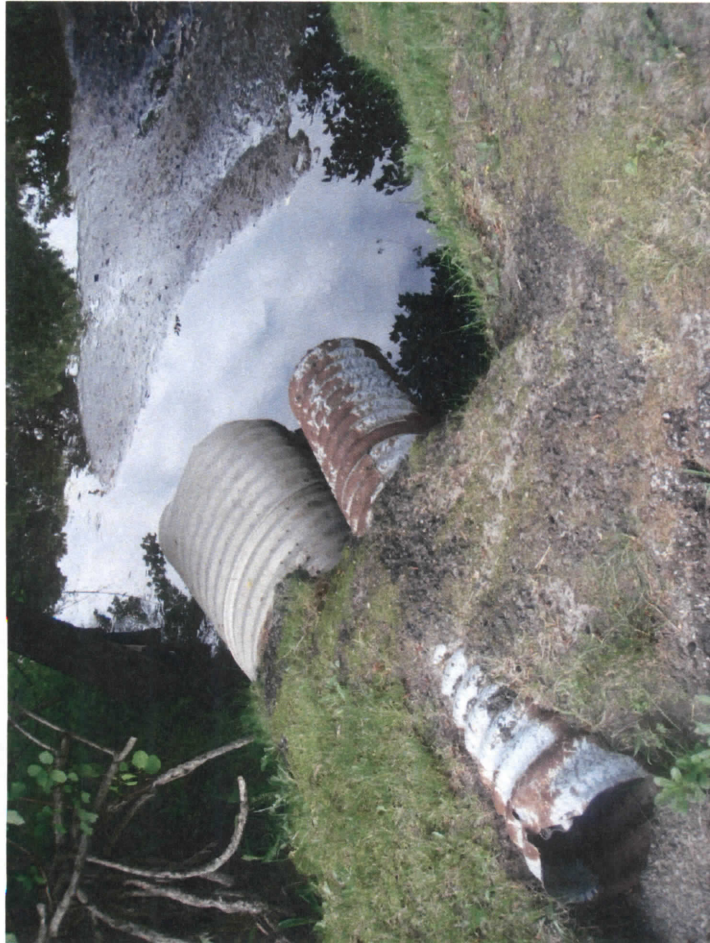
P7090094: Outfall 2 on Silverbrook Drive (12" CMP on right collecting drainage from roadway). The 24" CMP on the left appeared to be a culvert pipe.

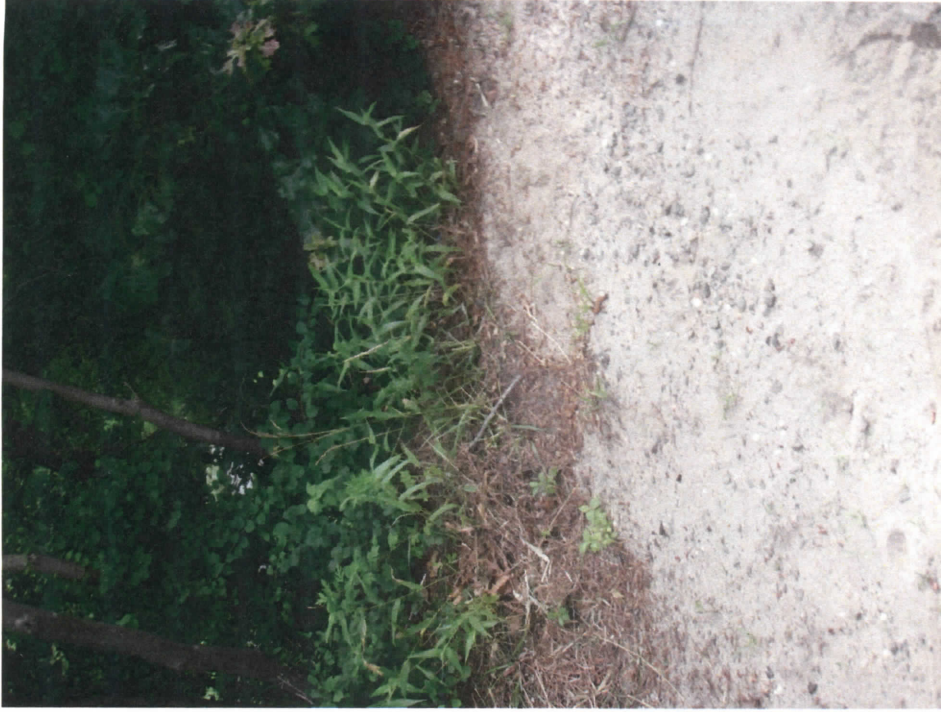
P7090098: Approximate location of Outfall 3. The outfall data sheet indicates that there is a 24" CMP from road into pond at this location. While a 24" CMP was identified, the upstream drainage structure was not.
